**Report on the Condition of
ten Churchyard Monuments
and
the Mediaeval Preaching Cross.**

**Prepared for the P.C.C. of the
Church of the Holy Rood, Ampney Crucis,
Gloucestershire.**

by G.B. O'Hare M.Phil. PG.Dip. (cons.)

December 2022.

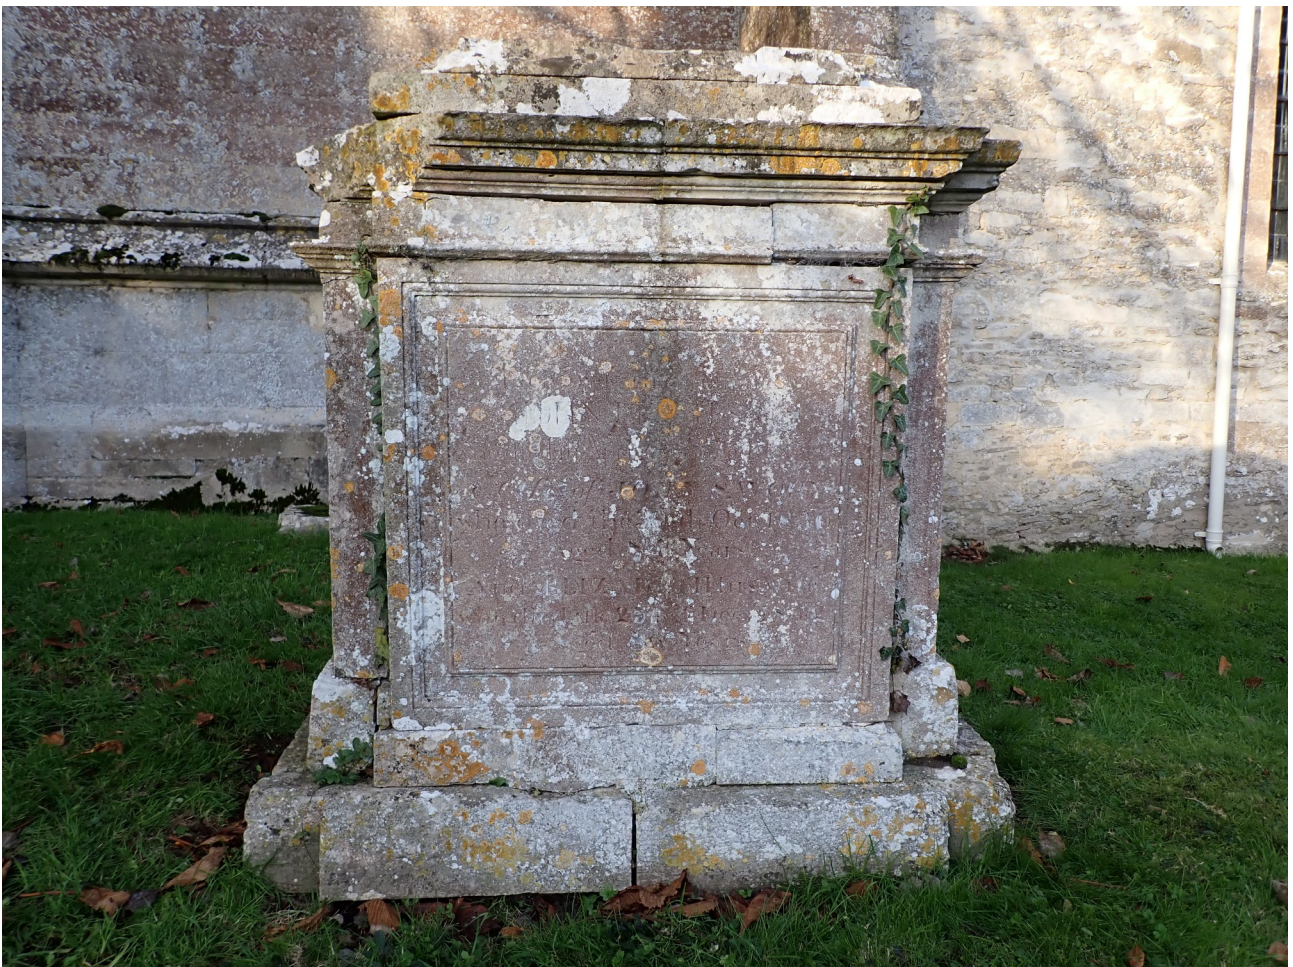
South side.

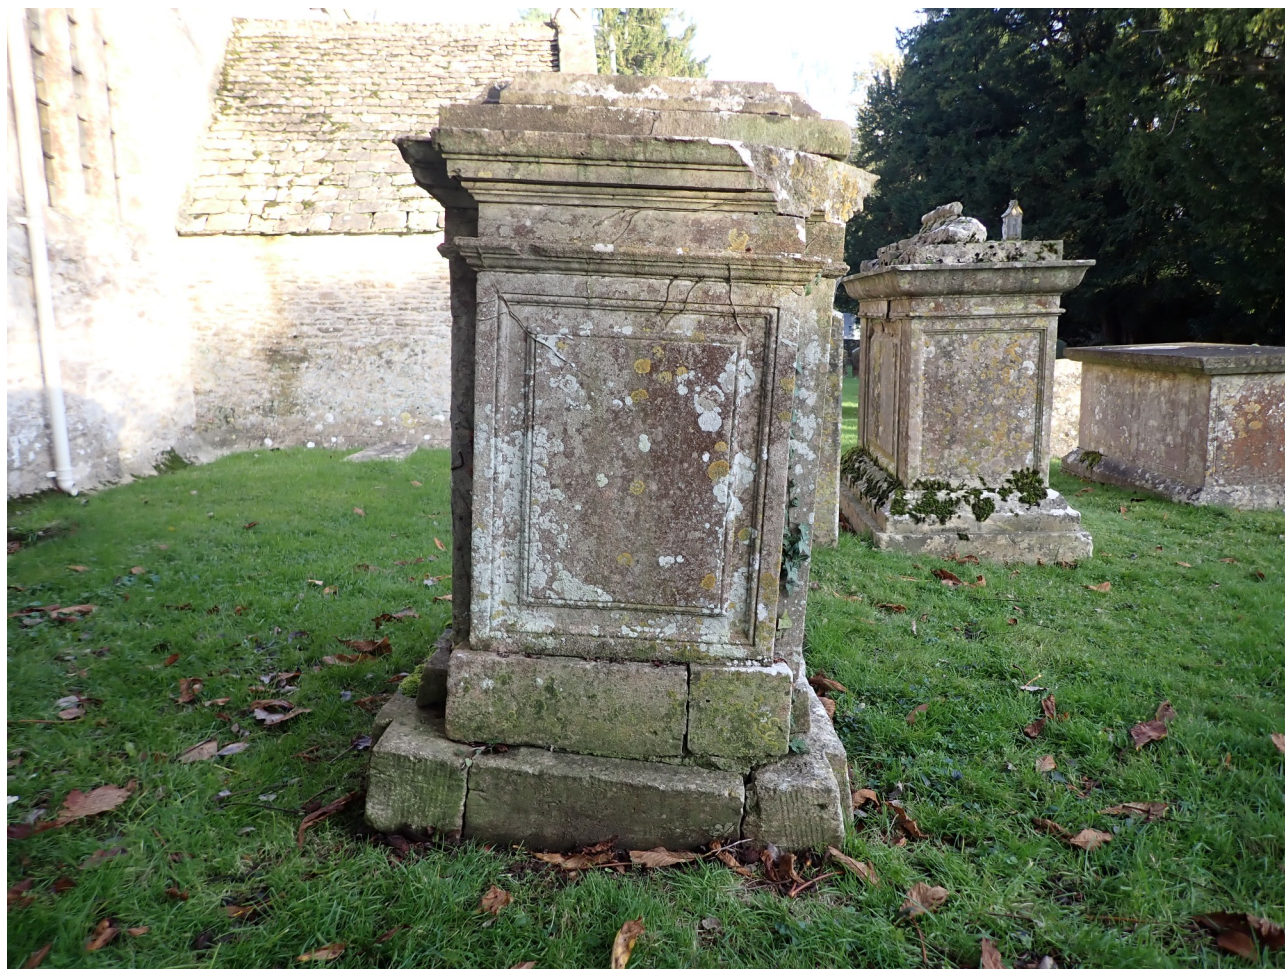
West end.

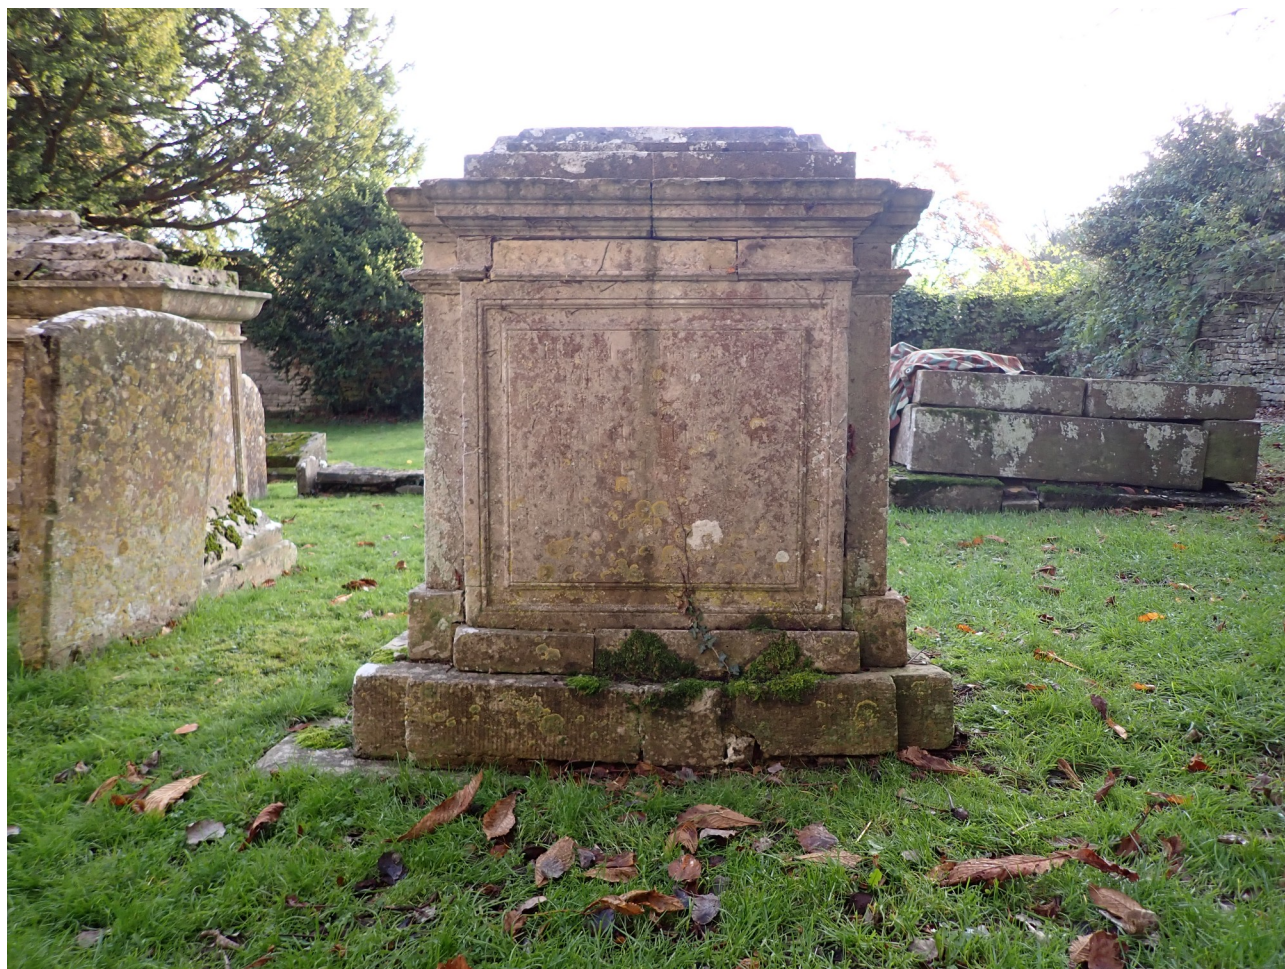
North side.

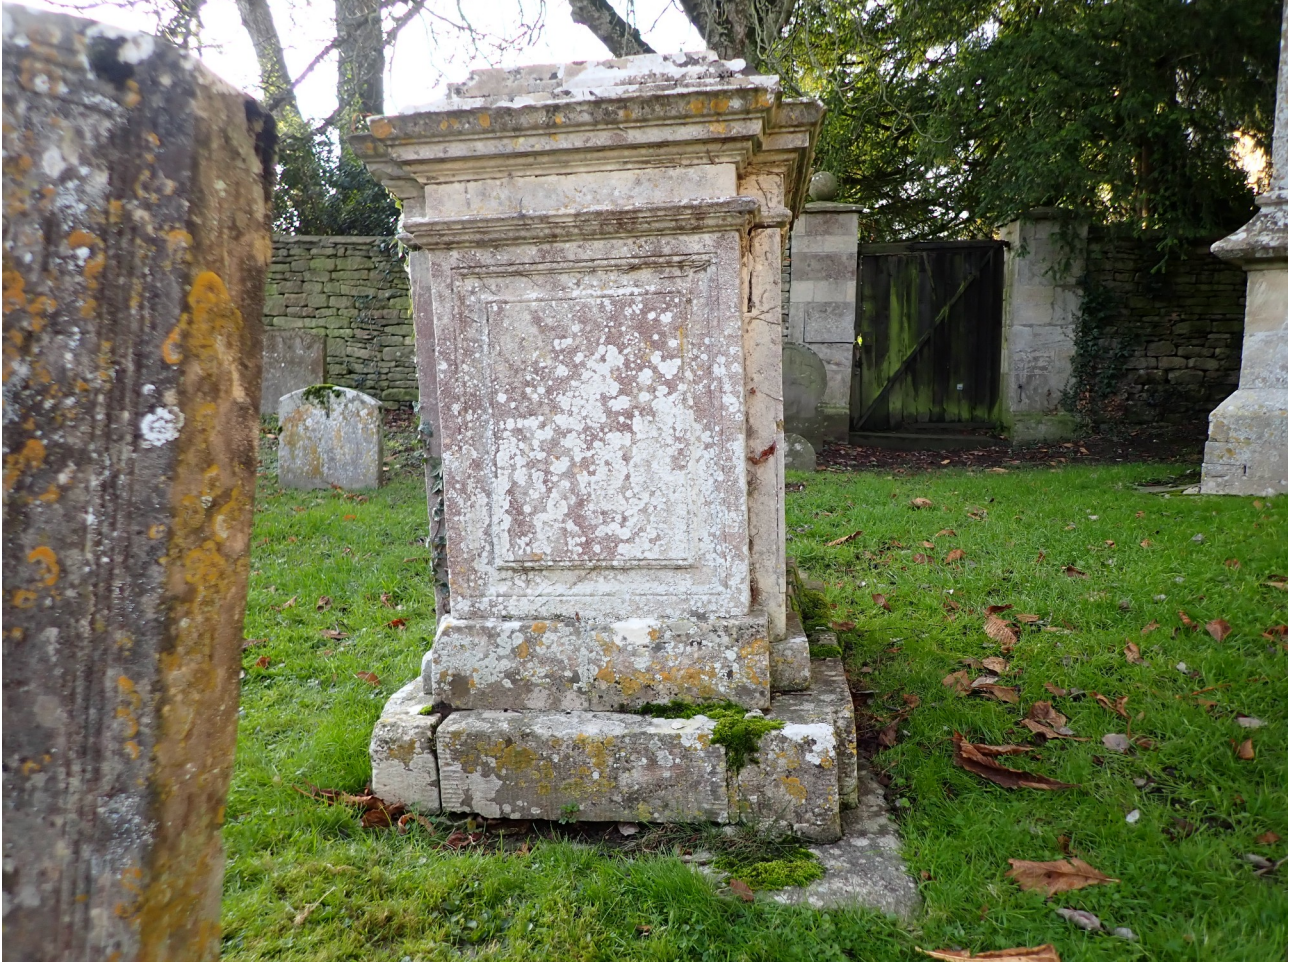
East end.

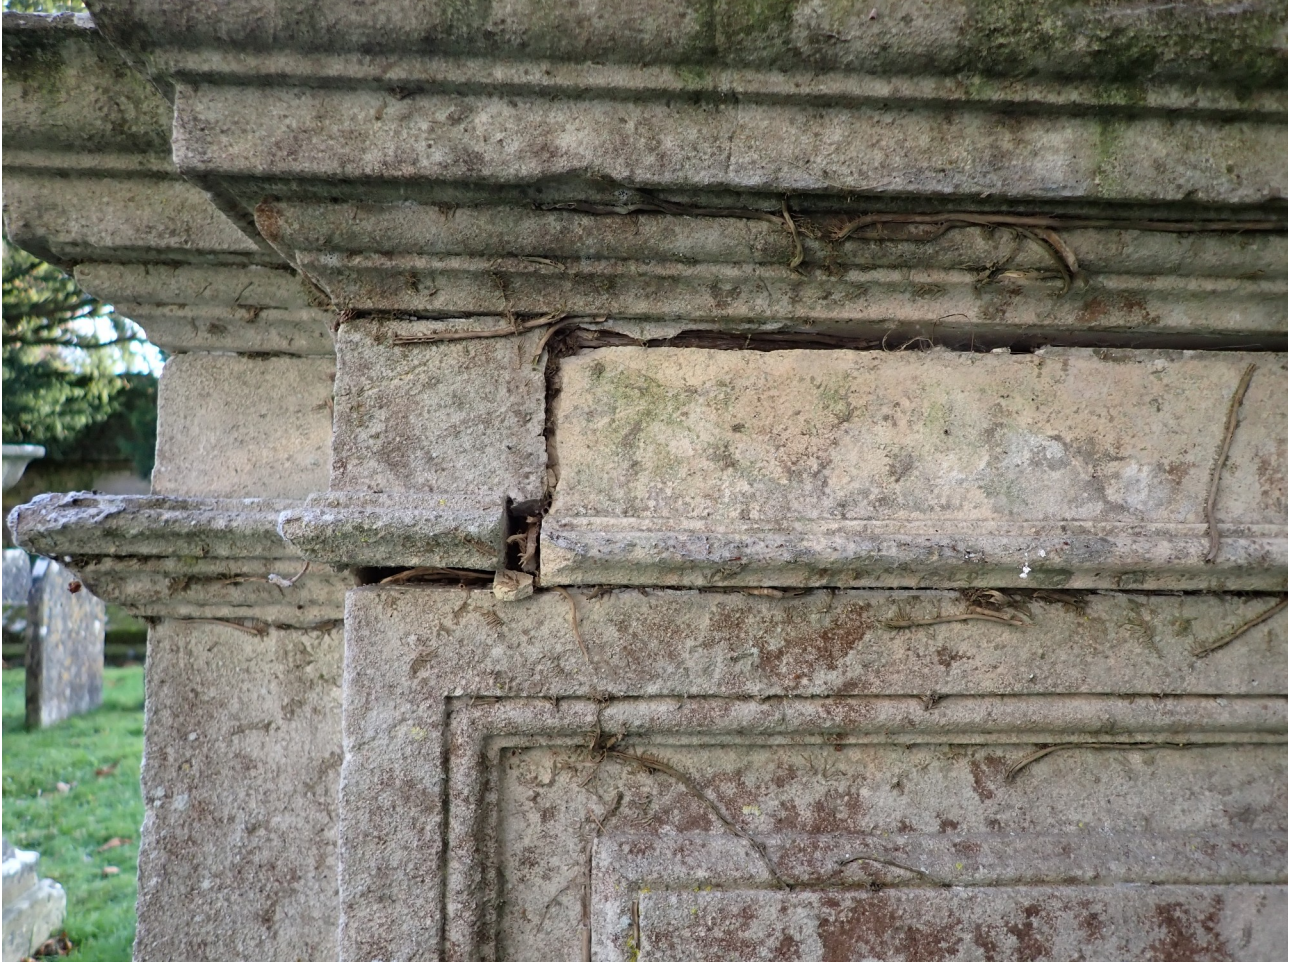
Individual stones are all in quite good though weathered condition, and with extensive yellow and white lichen growth. The covering slab has subsided to the SW. This movement has allowed all joints to open. Cramps may possibly have failed due to failure of the mortar allowing movement in their sockets, rather than damage to the cramps themselves, as there are no signs of damage to the surrounding stonework.

This monument has not been conserved previously, but has been repaired and extensively repointed using sand and cement. Movement has continued however, so that the joints have opened further.

Detail showing joints opened due to structural movement. The stones themselves are undamaged.

It should be completely dismantled, and the covering slab lifted out using a lifting gantry, chain-hoist and soft straps. The resulting hole can be lined with geotextile and filled with lime concrete to provide a firm and level foundation pad on which to re-lay the cover slab, now lifted up to the modern ground level.

The monument can then be rebuilt using lime mortar and replacing any iron cramps found with stainless steel ones.

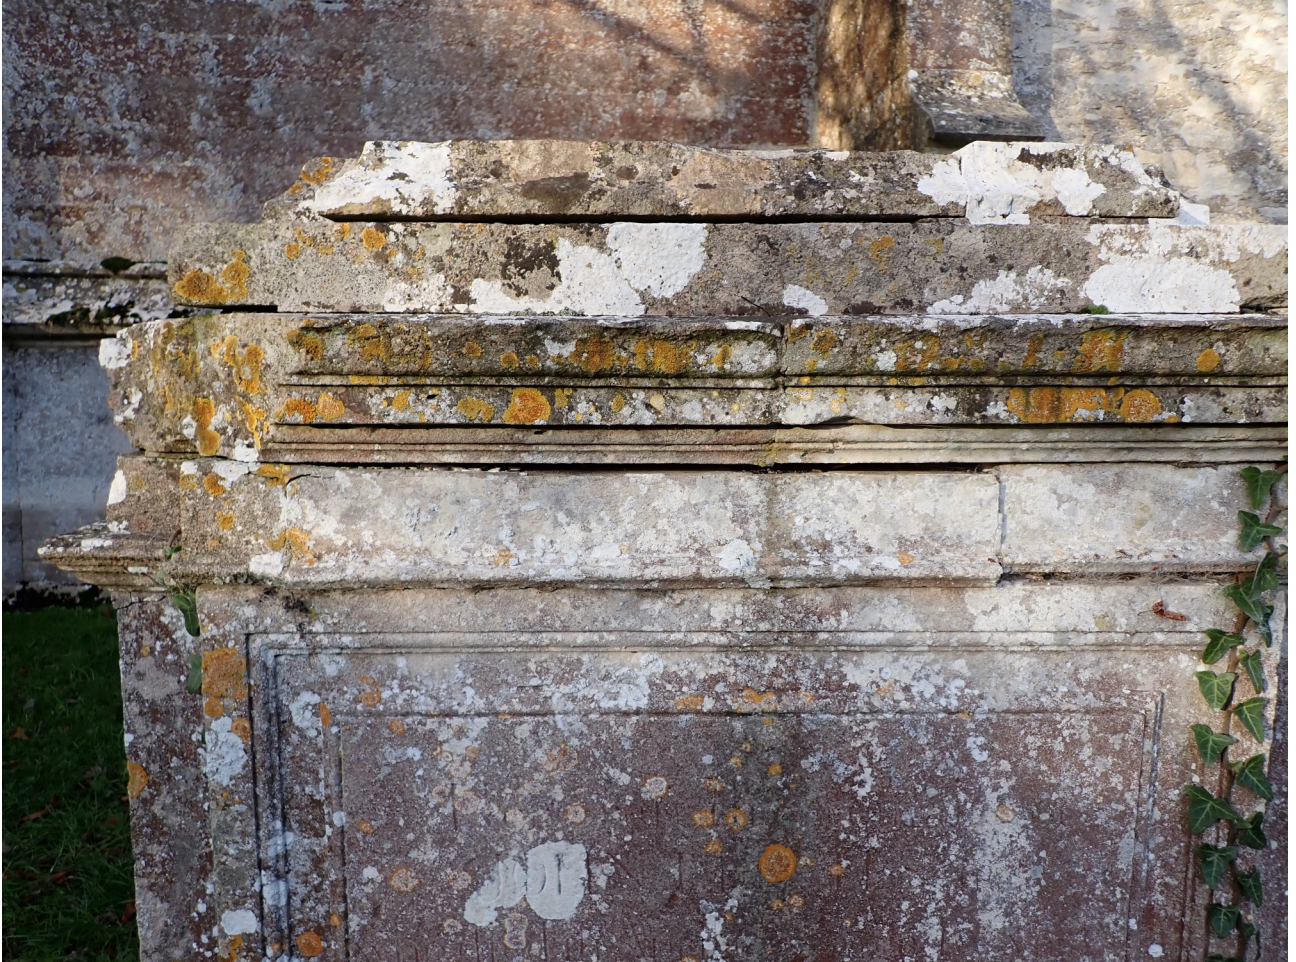
The south side, again showing opened joints.

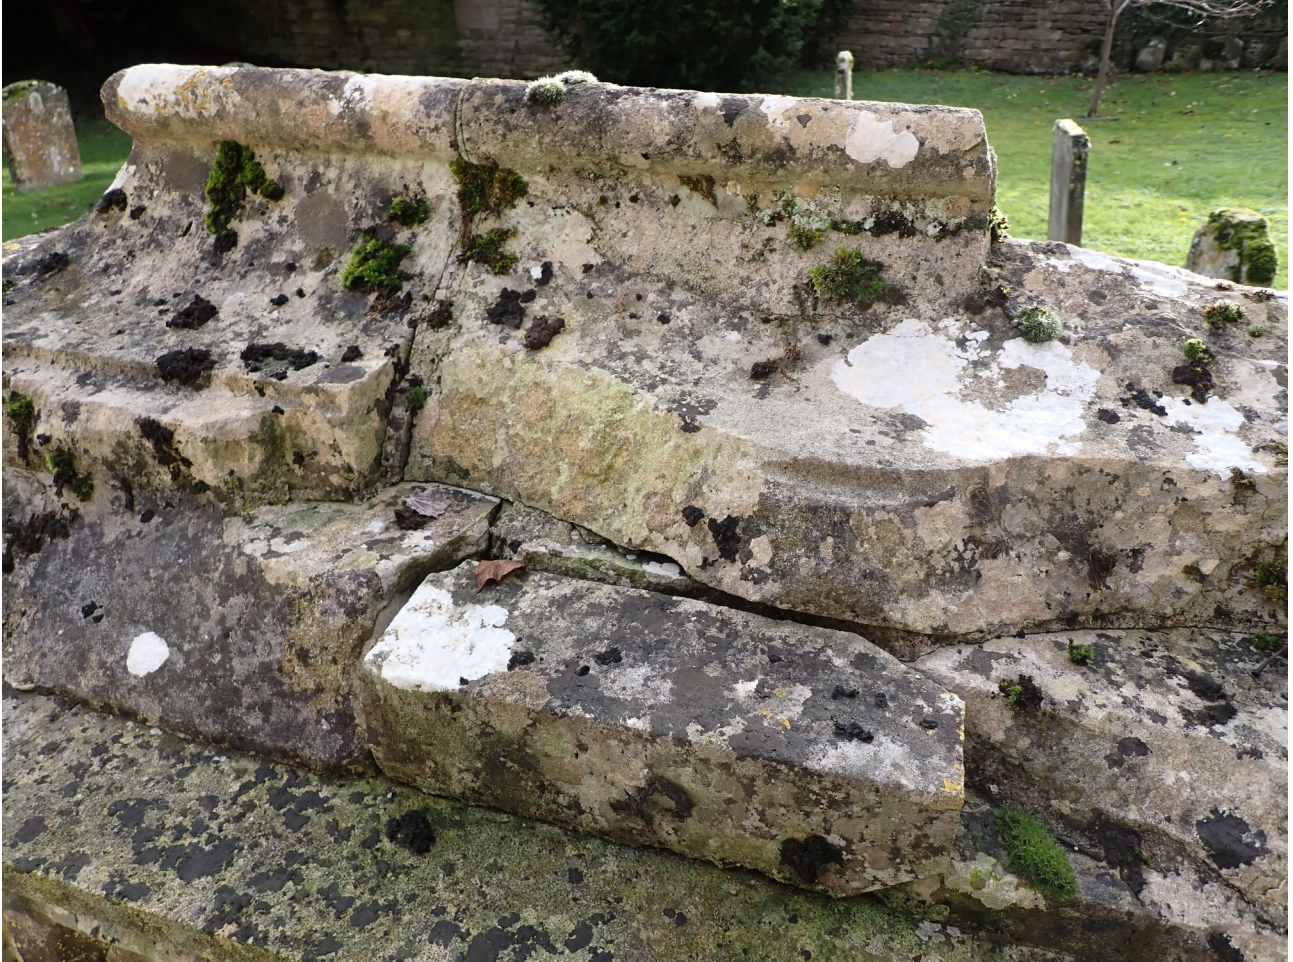
This monument has been conserved, reportedly by Maurice Hanks about twenty years ago. The covering slab is very level, and the monument may have been completely dismantled and rebuilt on a new foundation, though this is unclear. Iron cramps have been replaced with non-ferrous or stainless steel ones. Open joints have been repointed with sand and cement. The condition of the E and W ends is very good. The N side is good, but the pinkish cement mortar is unsightly, and deteriorating. The frieze course is in good condition, except on the N side, where it has snapped in two places, and the central part is frost shattered, with a large spall detached, glued back on with cement, then failed again. The lid is deteriorating badly. Although the two ends are quite good, the central stone on the S side is disintegrating due to frost damage, and the central stone on the N side is a newer replacement in Stoke Ground base bed Bath Jurassic oolitic limestone, but this too is suffering from frost damage. The blocking course is in poor condition, with extensive frost damage. The cap is very poor and about to disintegrate, except the E end section which still has all moulding details intact.

Detail showing frost damage to the cap stones on the north side.

All cap stones should be replaced with new, carved to replicate the original shapes.

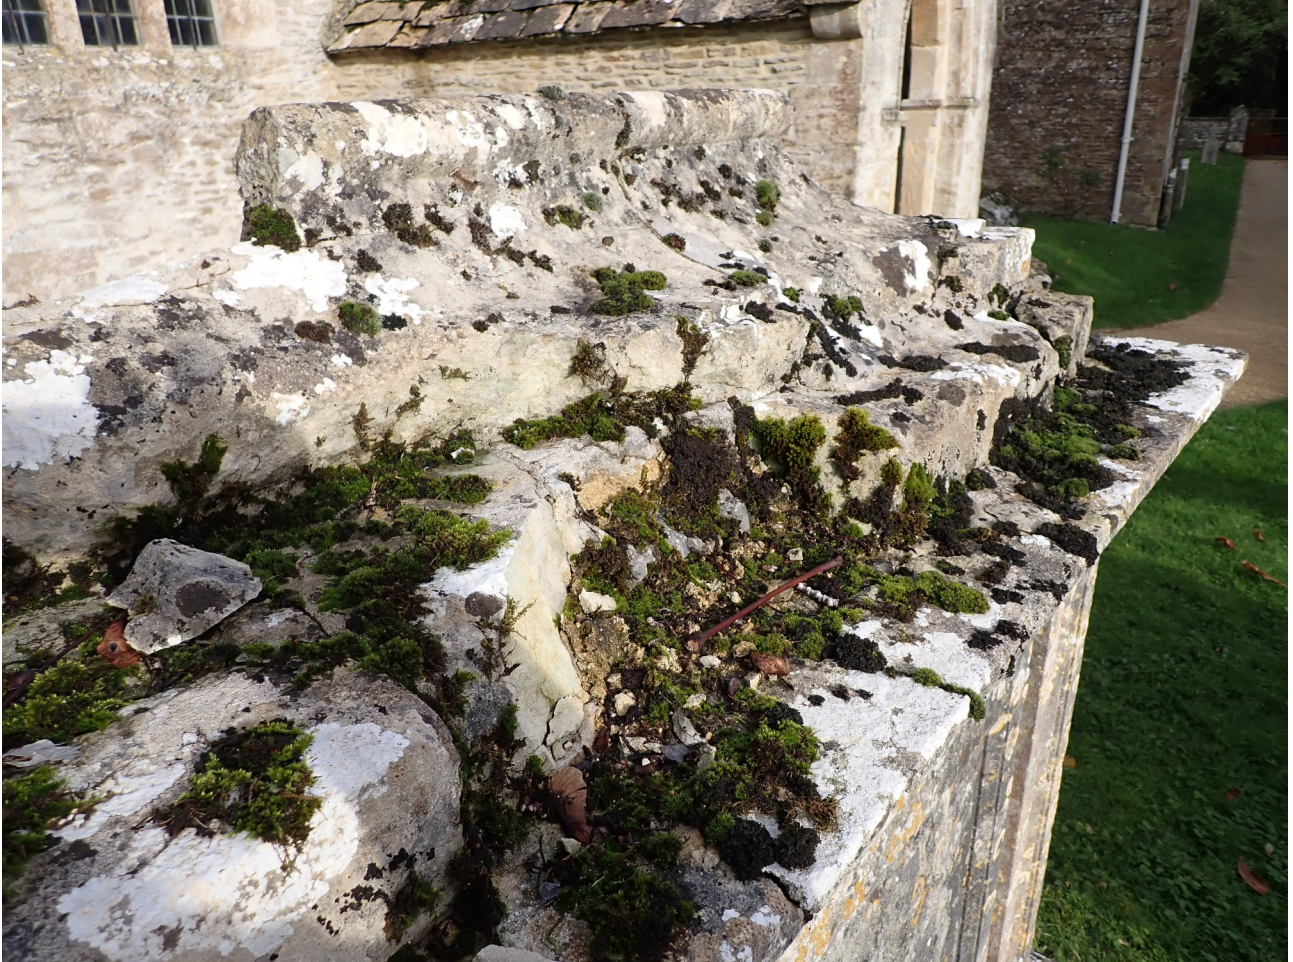
Frost damage on the south side of the cap.

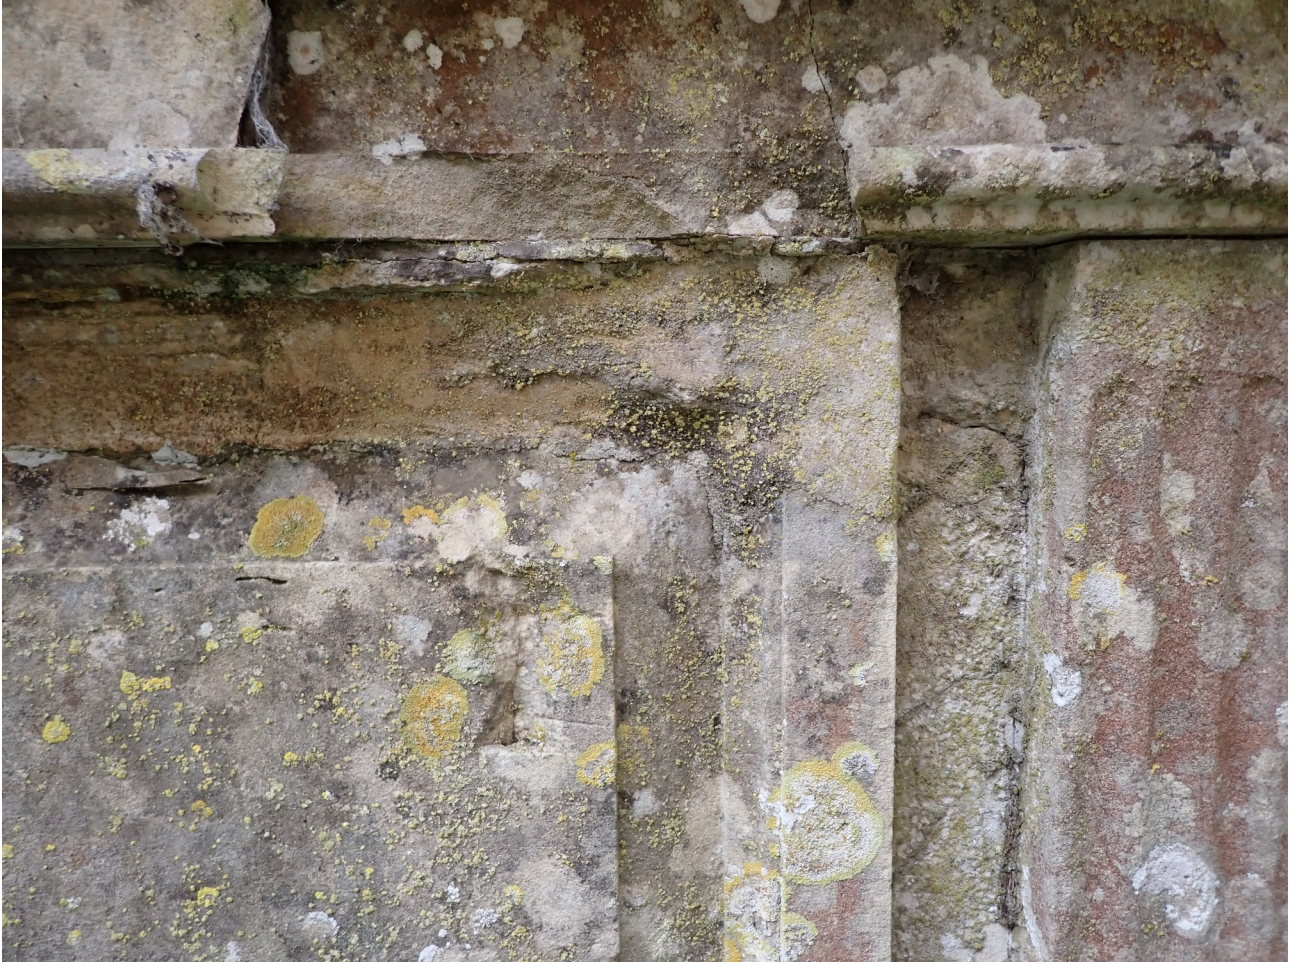
The N side is different, with a wider countersunk frame with *cavetto*, chamfered back out to a raised, flat inscription panel. This is empty, with no inscription. The top has been very crudely repaired with a pinkish cement render.

The crude mortar repair to the top of the side panel on the north side.

The monument should be dismantled to lid level, the N and S centre lid stones replaced, and the broken stone on the N frieze repaired by removing it and reattaching using polyester resin and small stainless steel pins and repair mortar.

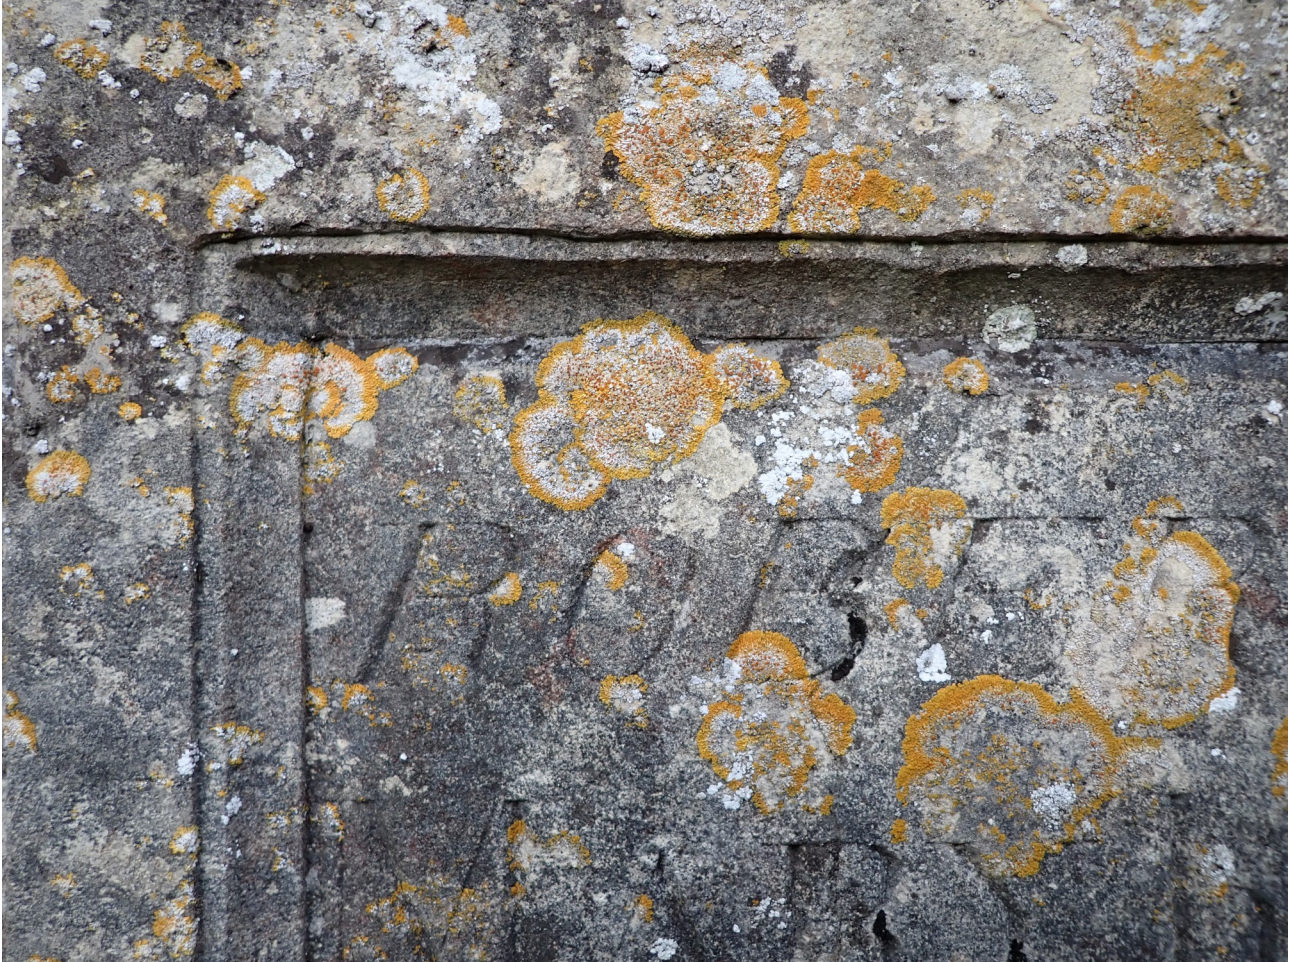
The S side is carved with a *cavetto* frame around a slightly convex inscription field. The top part, from the moulding upwards, is a replacement in two stones. The carving of the moulding is cruder than the original. The inscription reads:

The pieced-in stone repair on the south side. Note the difference in accuracy in the mouldings.

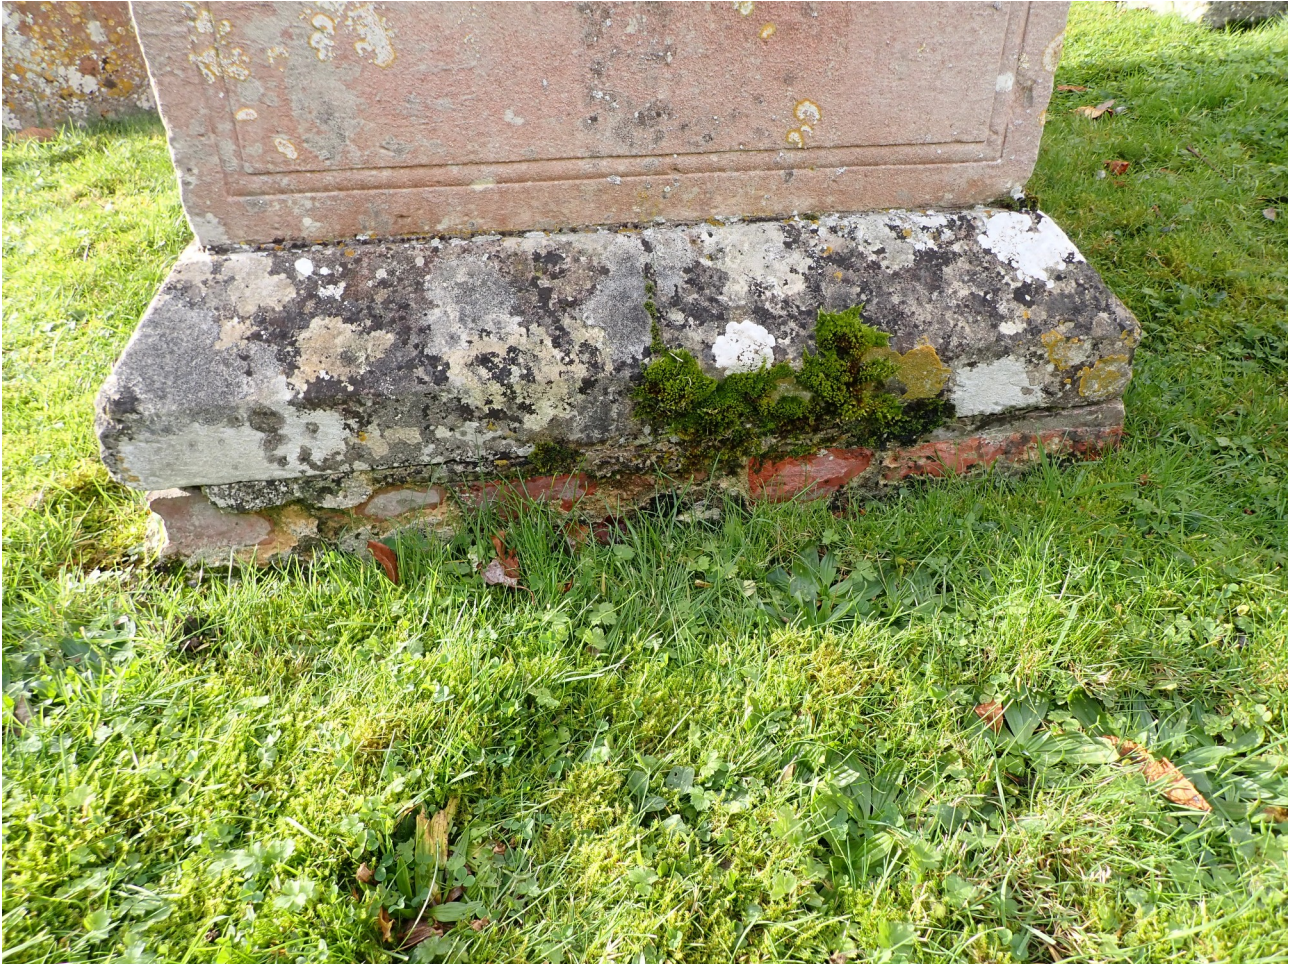
This monument has been dismantled and rebuilt previously, using sand, cement and stone glue. The plinth has been rebuilt square and level on a cement concrete base with an edge of modern bricks, which are visible beneath the stone plinth at the E end. There are no visible covering slabs over a shaft, and it seems likely that this had subsided and is buried below the modern ground level, with the later bricks and concrete used to level up and raise the plinth a little. Cramps are present across the top of each perpendicular joint below the lid, but are non-ferrous replacements. Joints have been filled with a sand and cement mortar.

Detail showing modern brickwork below the plinth course at the east end.

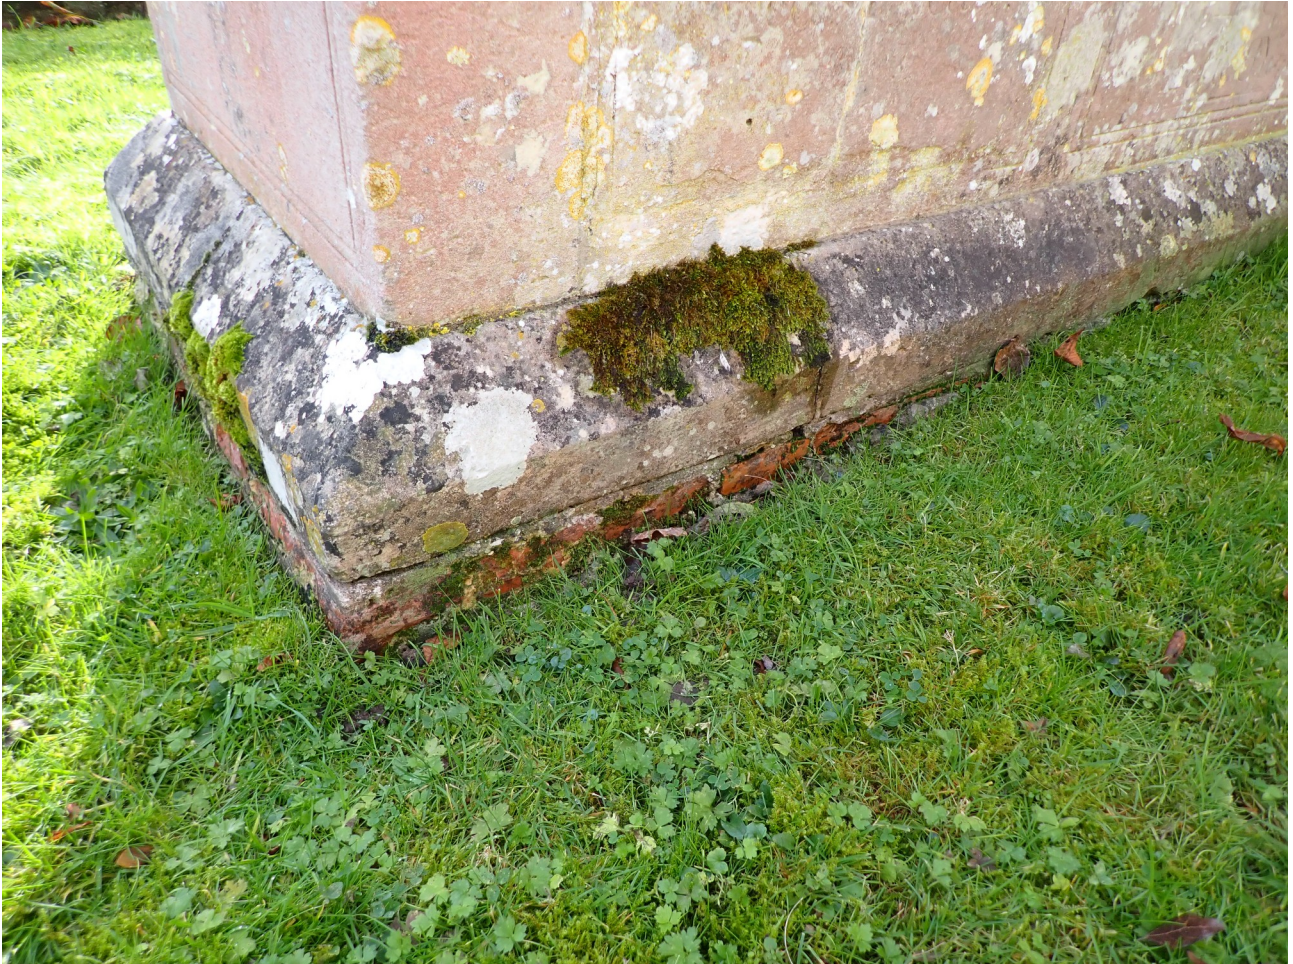
Detail showing modern brickwork at the north-east corner.

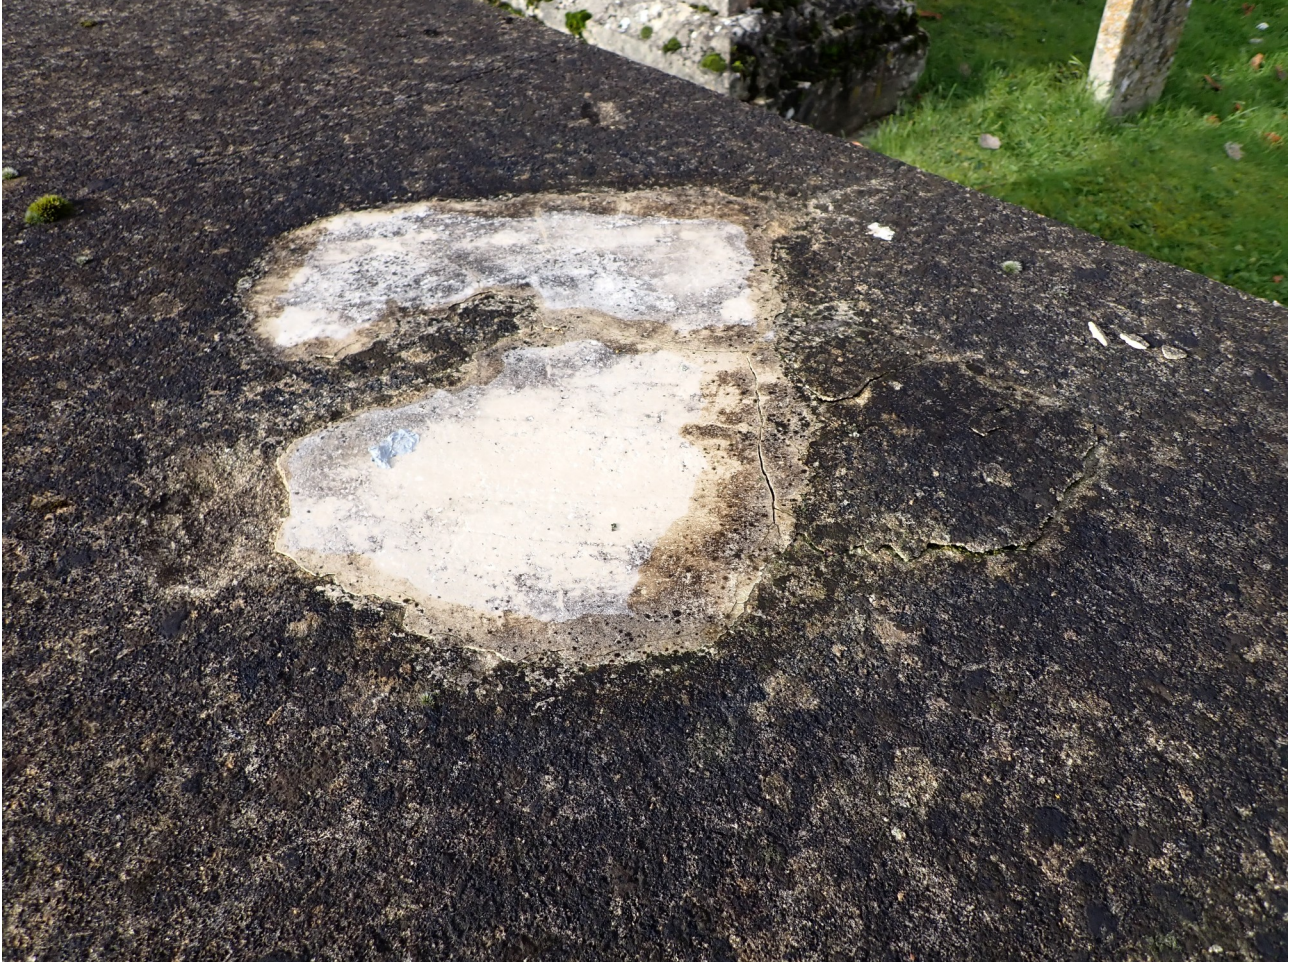
There is a relatively recent polyester stone glue filler repair to a large frost spall on the top of the lid. This is not working, and further frost damage is occurring. The cement-filled perpendicular joints have cracked through, but this is more likely to be due to thermal movements than subsidence or structural movement.

An area of frost damage to the lid has been repaired by filling with polyester resin.

Open joints should be repointed with lime mortar. The damaged area of the lid should be cut out, and a rectangular piece of replacement stone fitted in using an NHL 3.5 hydraulic lime mortar and fine sand.

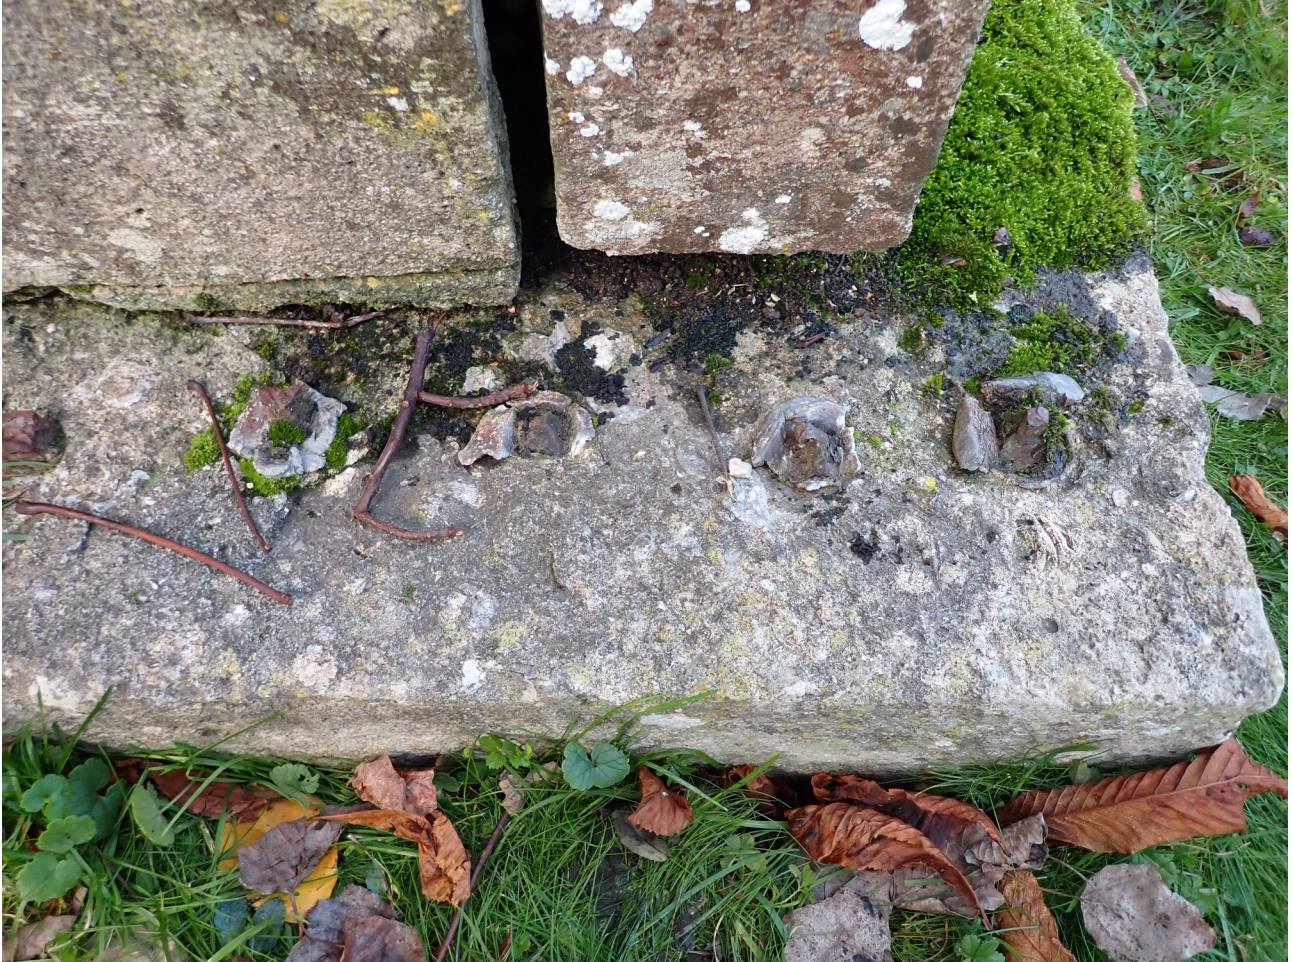
Removal of all ironwork (in the 1940s?) removed the ties fixing the four plinth stones together at the corners, allowing everything to move. Subsidence of the slabs has then caused movement. The subsidence may be caused by deterioration of the top few courses of a brick-lined shaft or vault beneath. Movement has opened up all the joints, allowing the weather to remove any mortar completely.

Detail showing the remains of cut-off iron railings, set in lead.

This monument would benefit from being dismantled and rebuilt. It is likely that the top of any structure underneath will need to be repaired. The extent of this work would need to be assessed after removal of the stones above.

It should be dismantled using a lifting gantry, chain-hoist and soft straps, and rebuilt using hydraulic lime mortar.

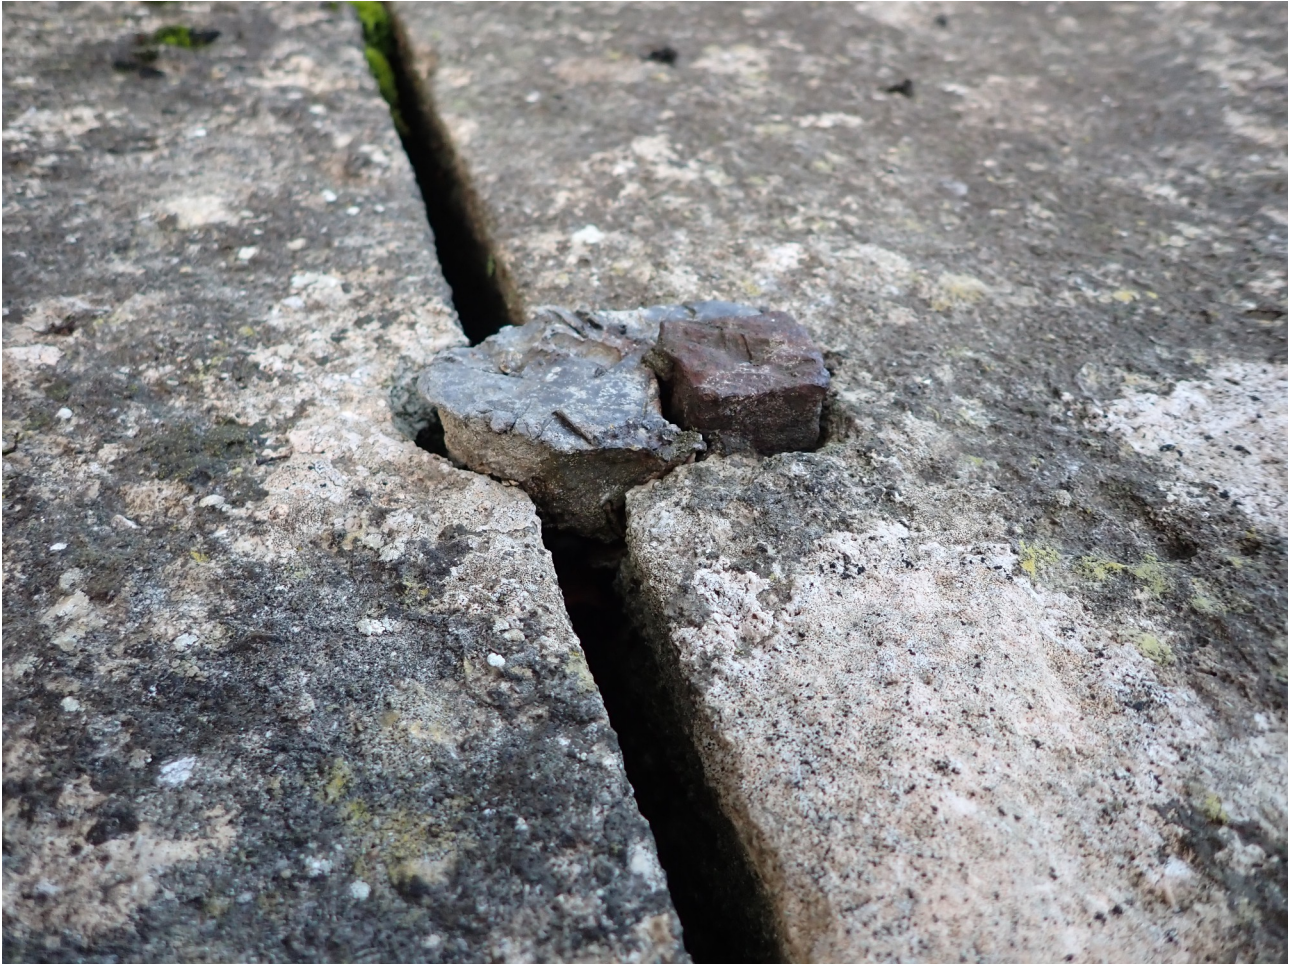
Detail showing one of the cut-off iron braces.

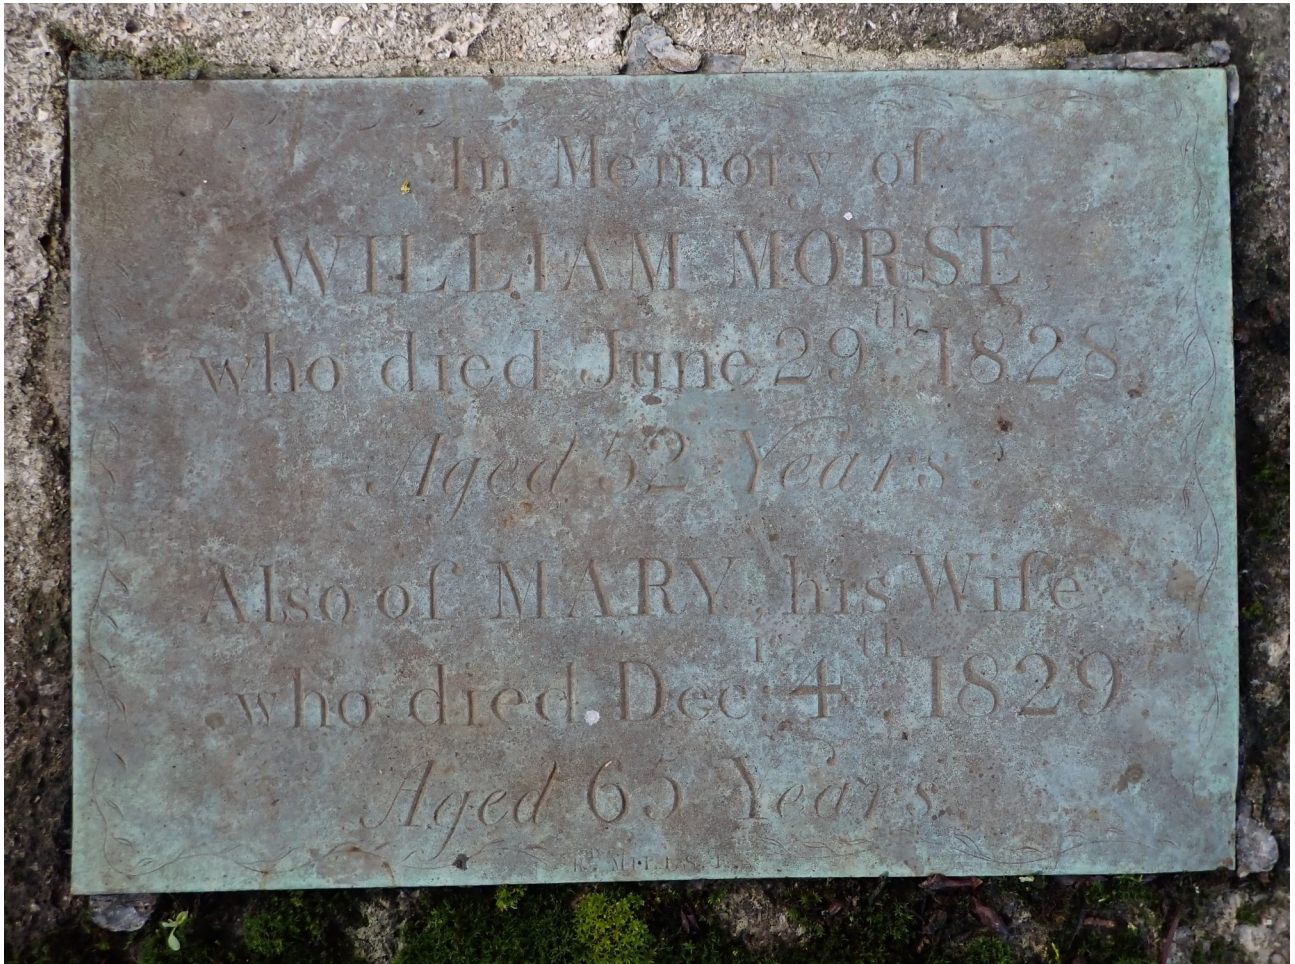
The engraved copper inscription panel set into the western ledger stone.

The copper plaque should be lightly cleaned and protected with a coat of “Renaissance” wax.

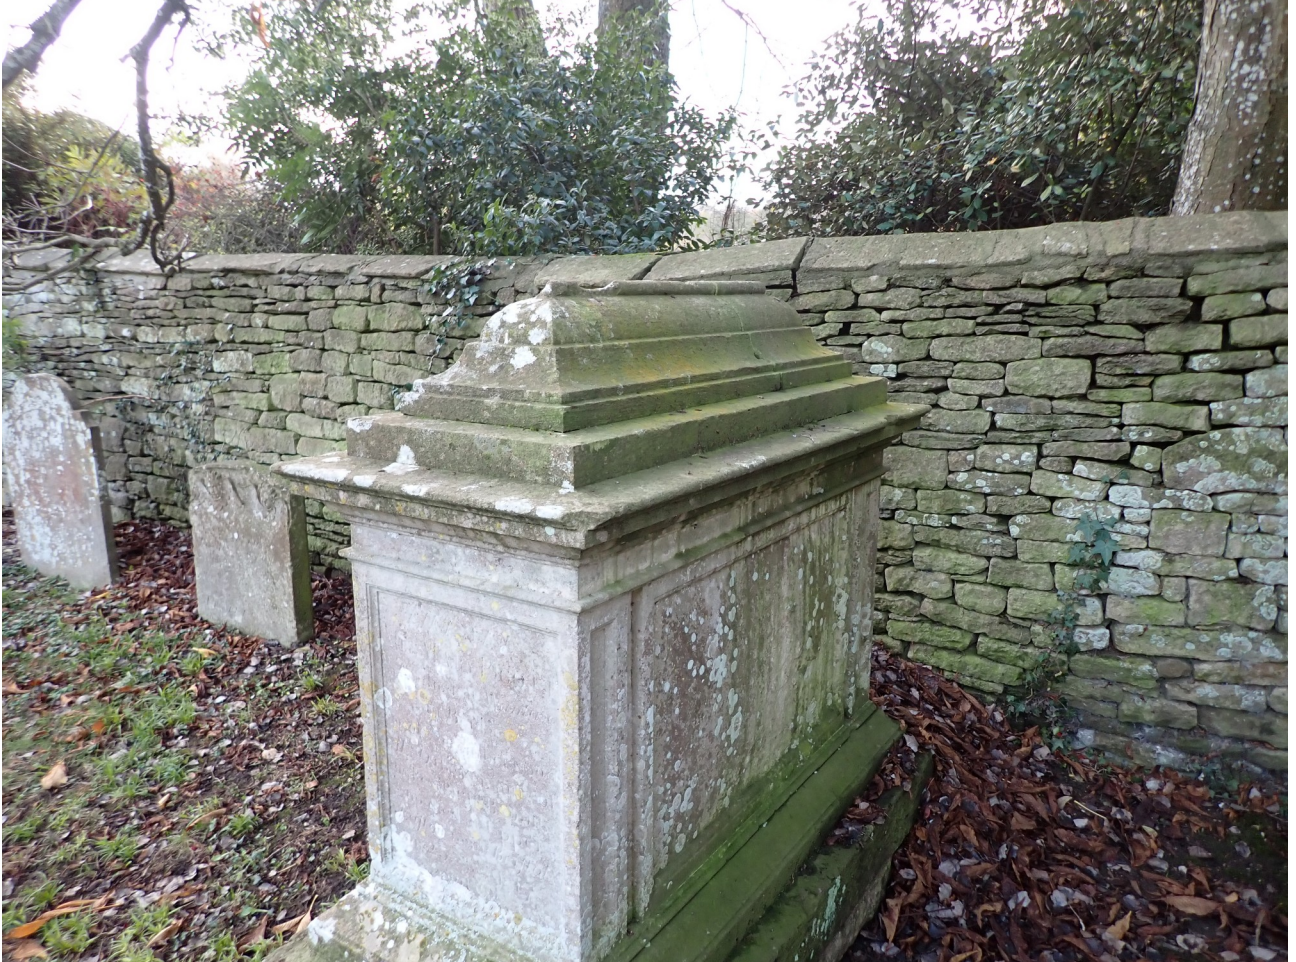
This monument is in remarkably good condition. All stone is only moderately weathered, with the exception of the N side panel where there has been some loss to the surface of the inscription field, obscuring some of the letters and numbers. There is no damage from deteriorating cramps (they are probably copper), and no movement. It was built with very tight, narrow joints and lime putty as a mortar, and this has weathered away in a few places, most notably the perpendicular joints above the lid, in the cap and blocking course.

Detail showing the lid and cap.

This monument is in good condition and requires little work. Open joints should be repointed using lime mortar.
