**Report on the Condition of
ten Churchyard Monuments
and
the Mediaeval Preaching Cross.**

**Prepared for the P.C.C. of the
Church of the Holy Rood, Ampney Crucis,
Gloucestershire.**

by G.B. O'Hare M.Phil. PG.Dip. (cons.)

December 2022.

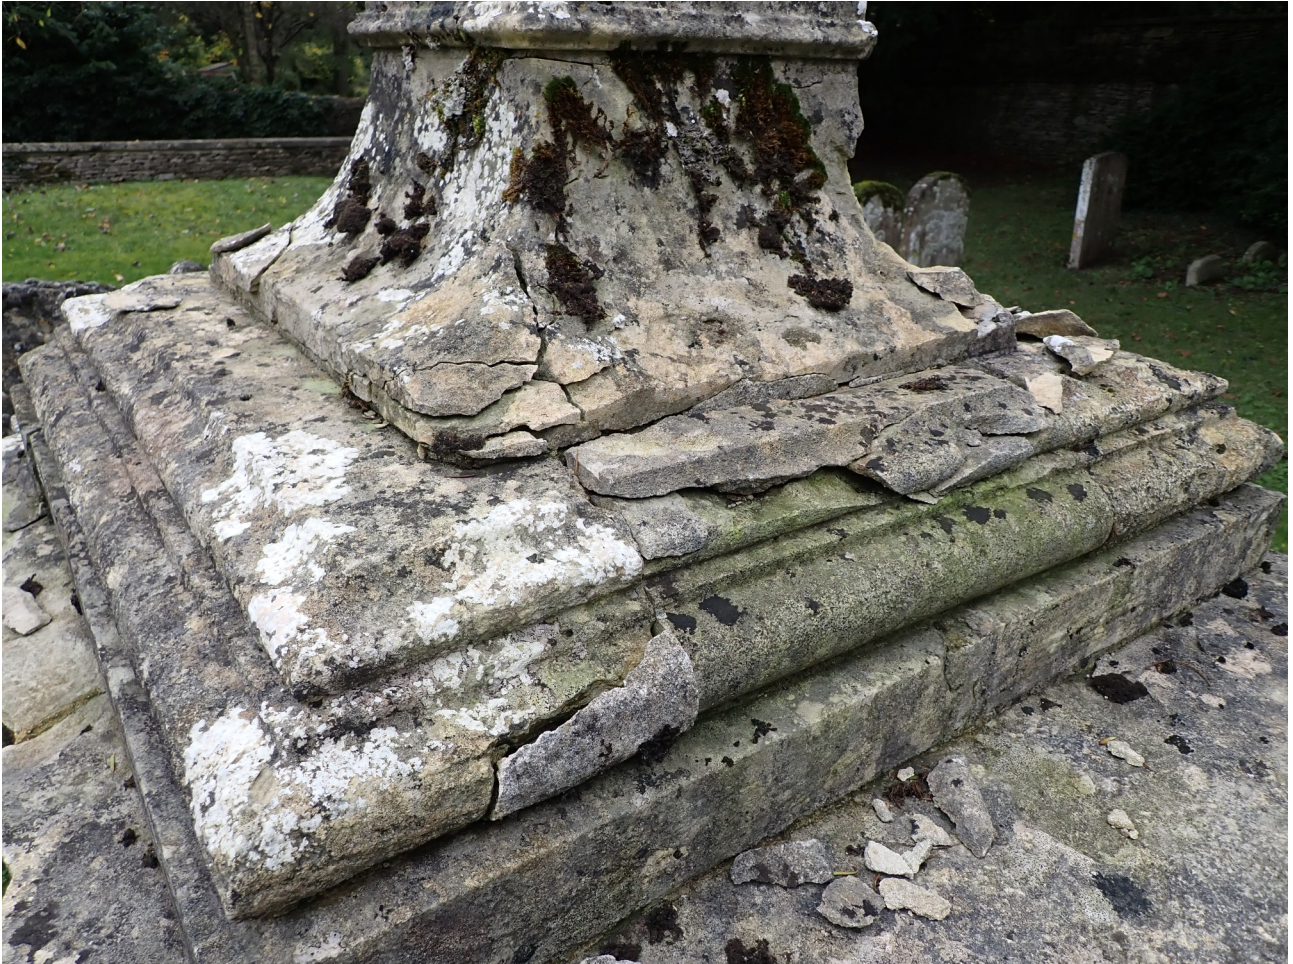
The edges of the lid have been eroded, shattered by frost. There is also frost damage to the moulded course below the socle. On the W side is a replacement stone (Stoke Ground Bath stone or similar), fitted well with lime mortar, but the top of this is also frost damaged. The socle is badly frost damaged, and about to lose all its corners. The cap is still good.

Detail showing the frost-shattered socle.

While most of this monument is in good condition, the lid and socle are deteriorating rapidly due to frost damage. The edges and top surfaces of the lid stones should be repaired by piecing in new stone, and the socle should be replaced.

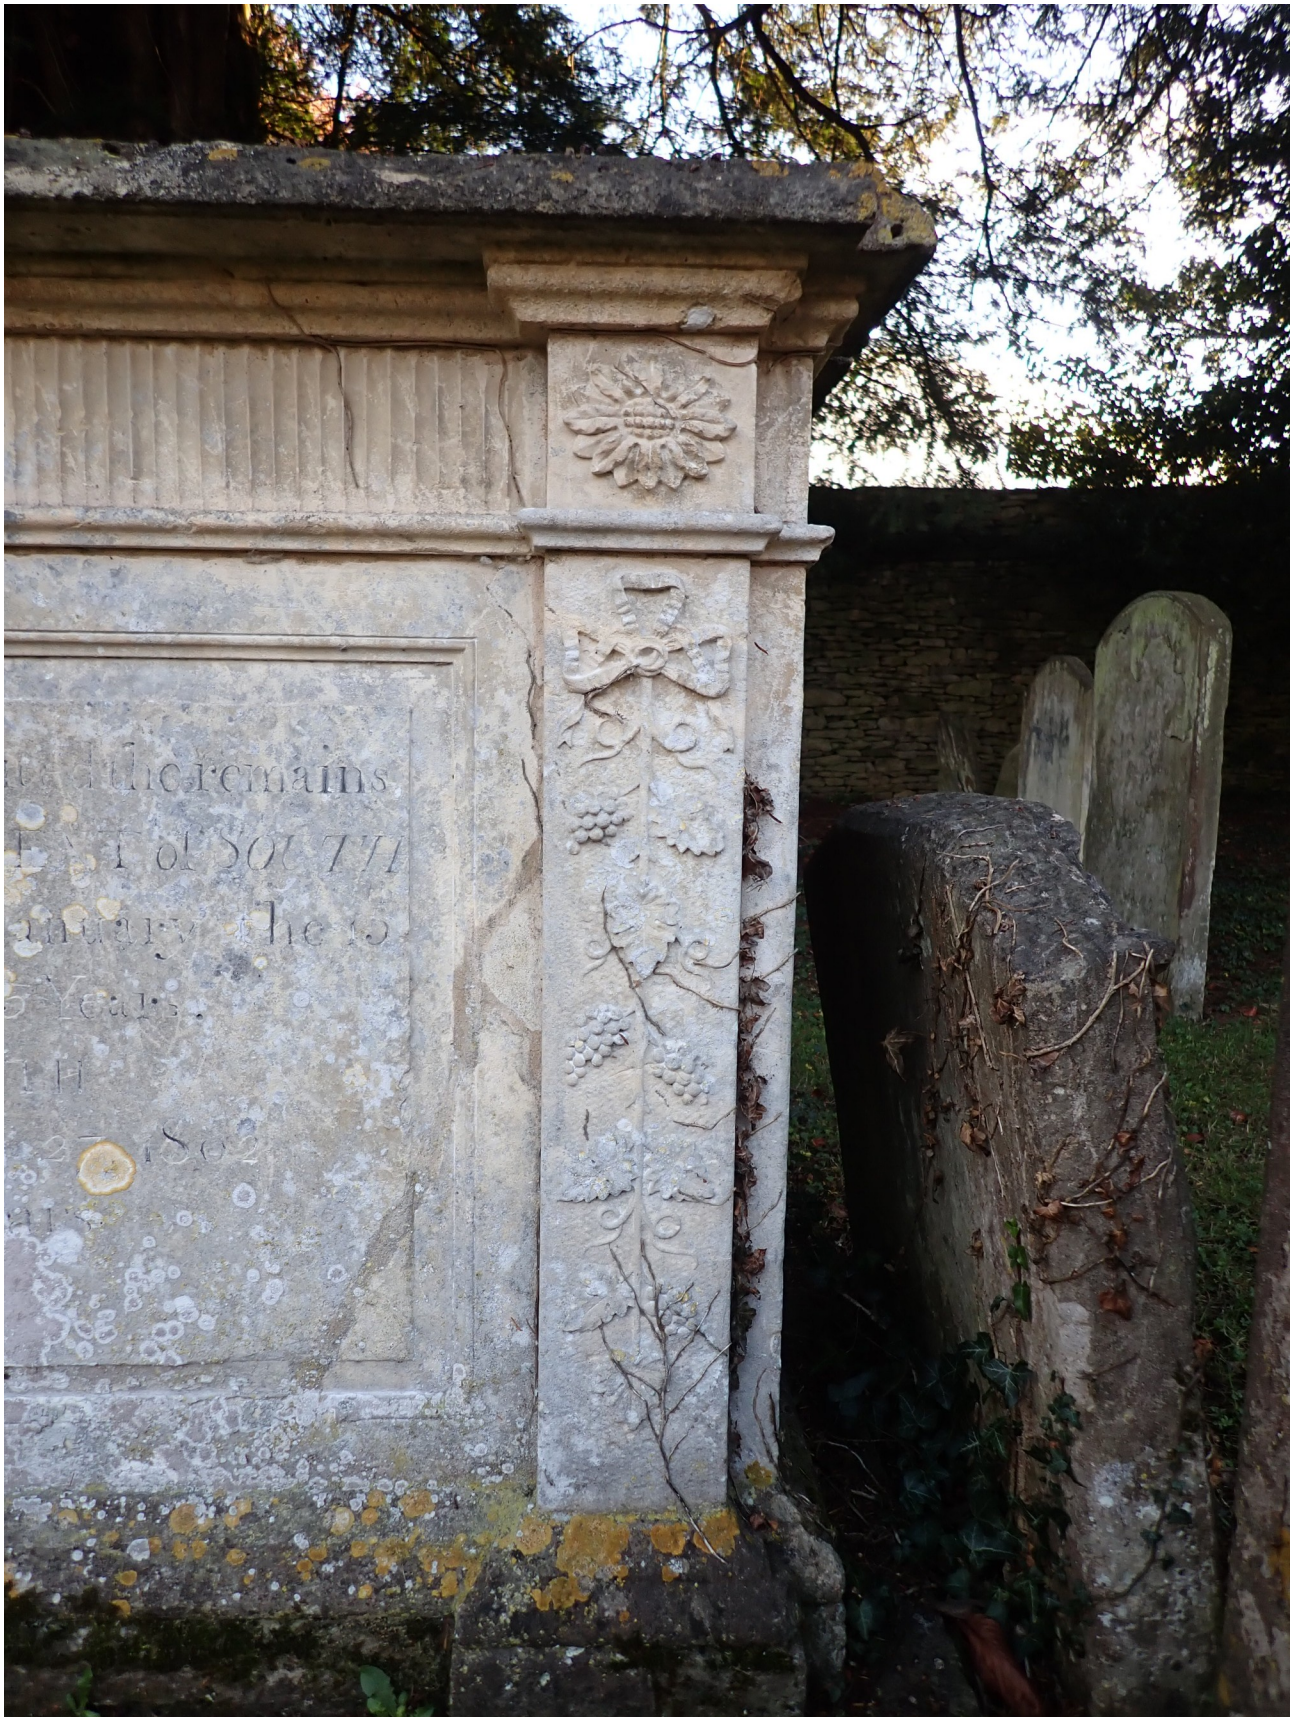
The north-west pilaster, showing the vine motif carved in relief.

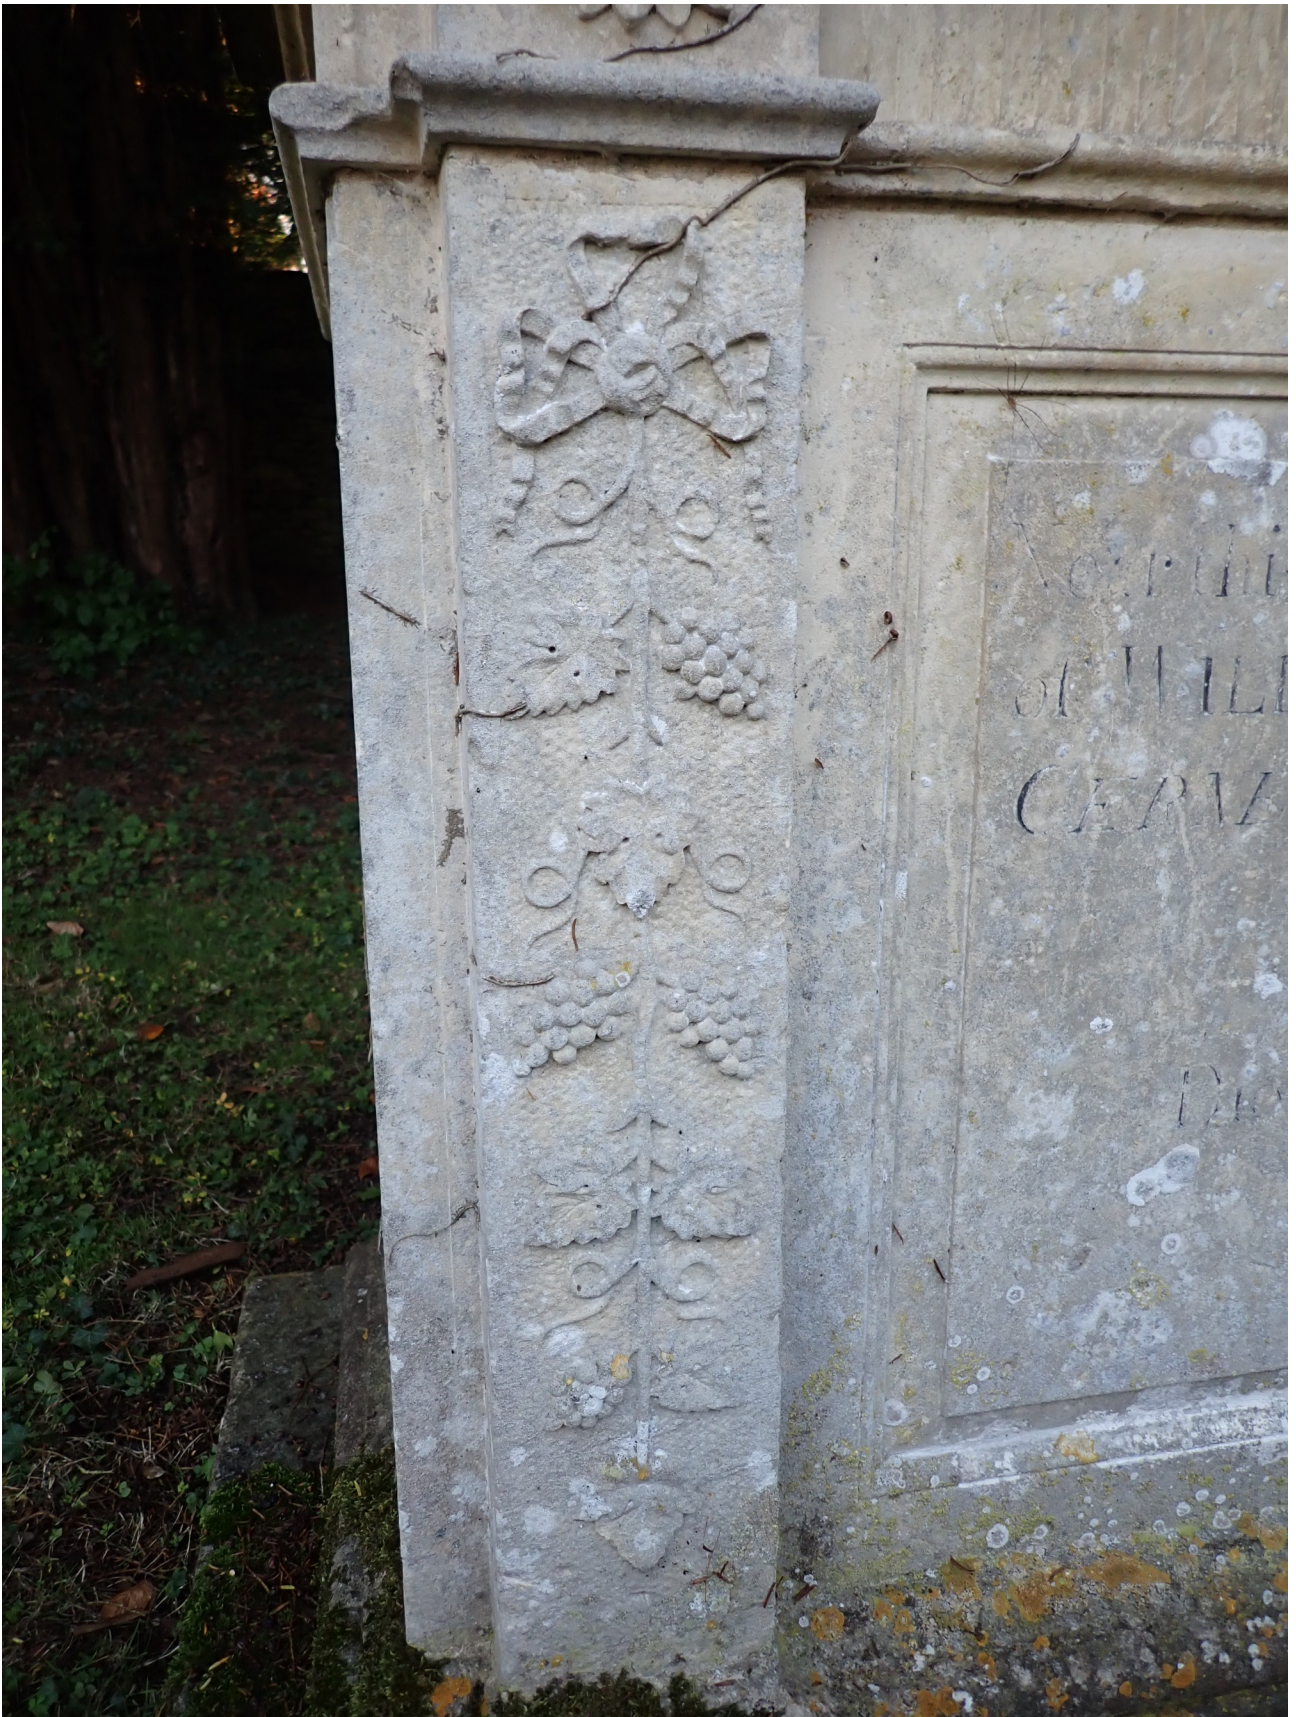
The relief-carved vine motif. Note the “sparrow-pecked” background.

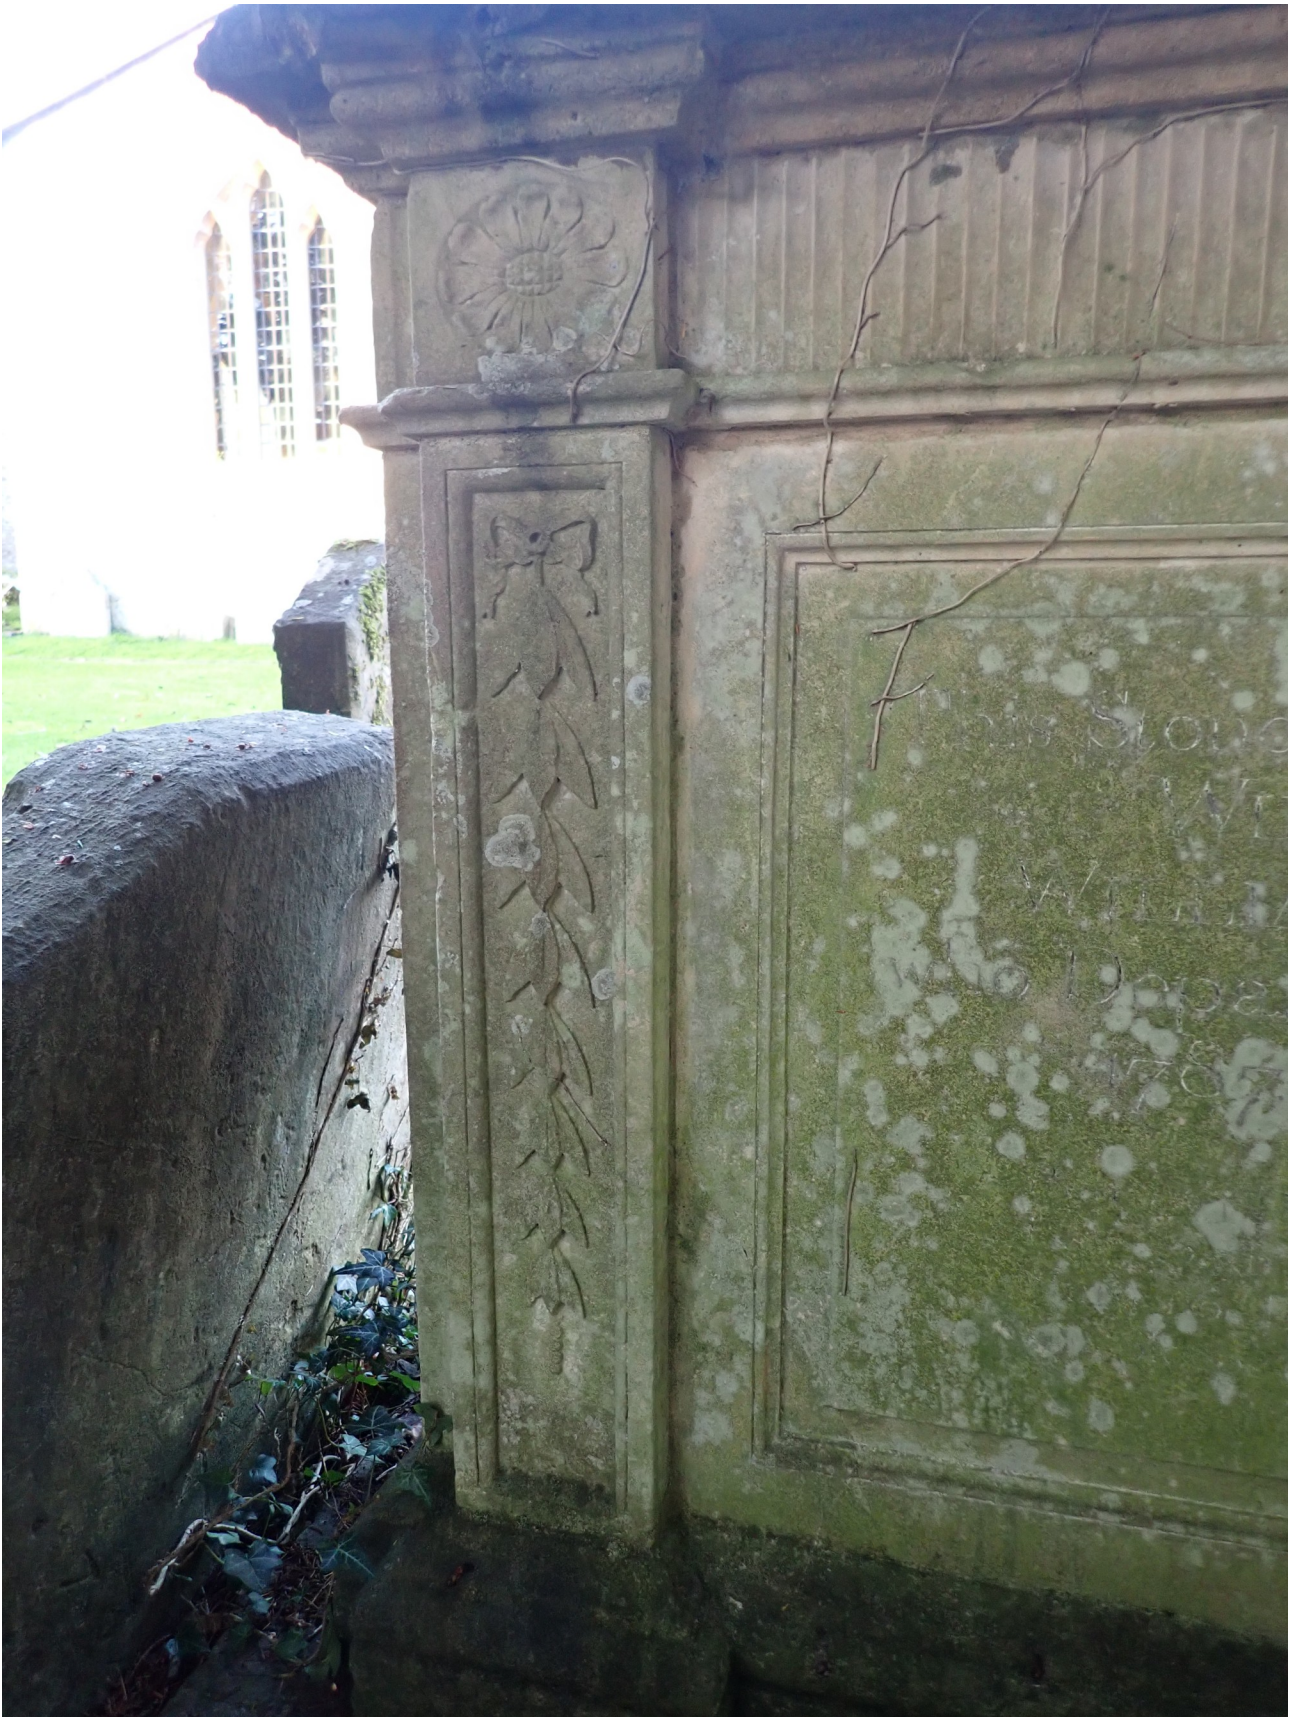
The south-west pilaster, with laurel leaves carved by countersinking around them.

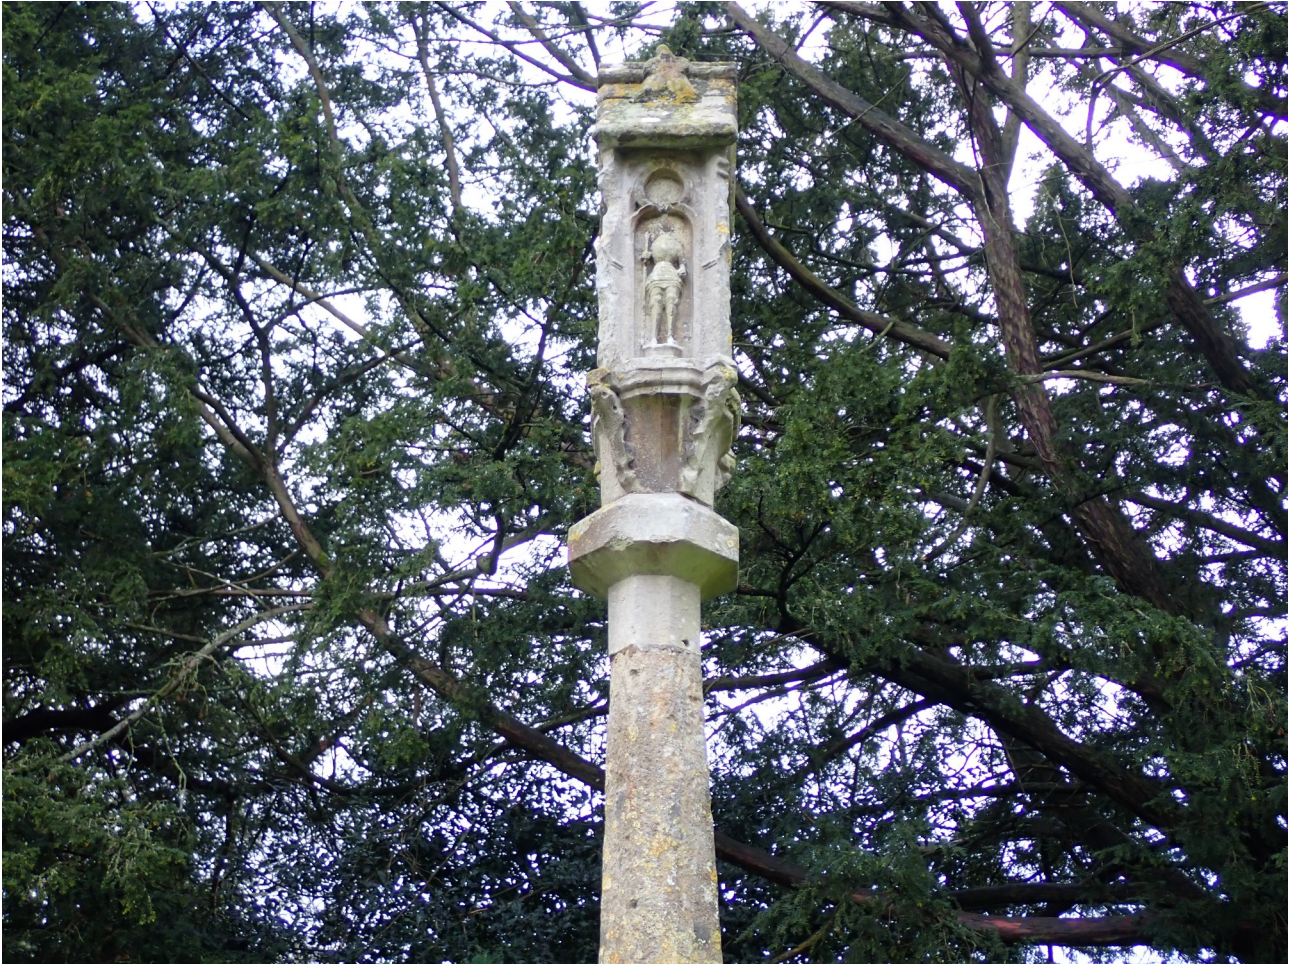
The lantern top is a single block of stone. Pooley's drawing of 1868 shows that the bottom part below the carved figures on the E side was damaged or badly weathered. This area has been repaired by piecing in new stone and copying the details from the surviving W side to match. The collar at the top of the shaft is a replacement. It is fitted to the top of the surviving, original shaft with cement mortar, and there must be a dowel of some kind too.

The north side. The lantern top.

One application of limewater should be given, until the water begins to "sit" on the surface of the stone. The limewater should be seen as a catalyst to the recrystallisation of broken calcite crystals, rather than as a consolidant *per se*. This follows German practice and research, rather than the "Baker Method" used at Wells Cathedral. Alternatively "Nanolime" can be used in the same way.

The lantern top should then be protected with a lime putty-based shelter-coat, mixed to match the colour of the stonework.

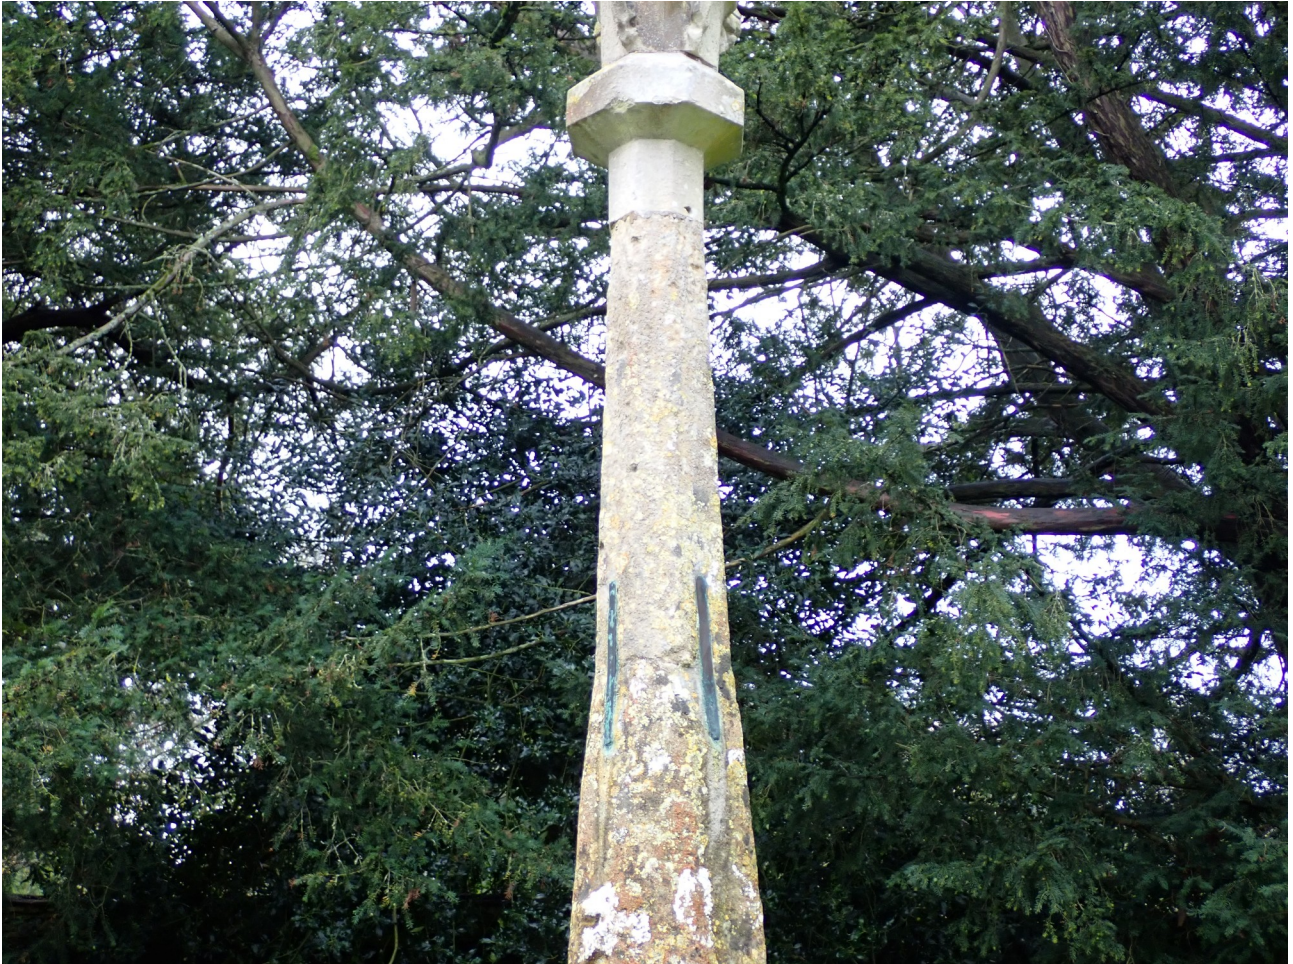
The bronze cramps and sand and cement mortar on the top, collar, shaft and base are weathered but in good condition and still functioning properly.

The north side. The shaft cap and bronze cramps.

While the cross is structurally stable, it would benefit from some maintenance. Any gaps around existing joints and mortar down to the level of the top step should be pointed and filled with lime mortar. The existing cement mortar should not be removed, as although it is hard it is not causing problems, and removal could cause damage.

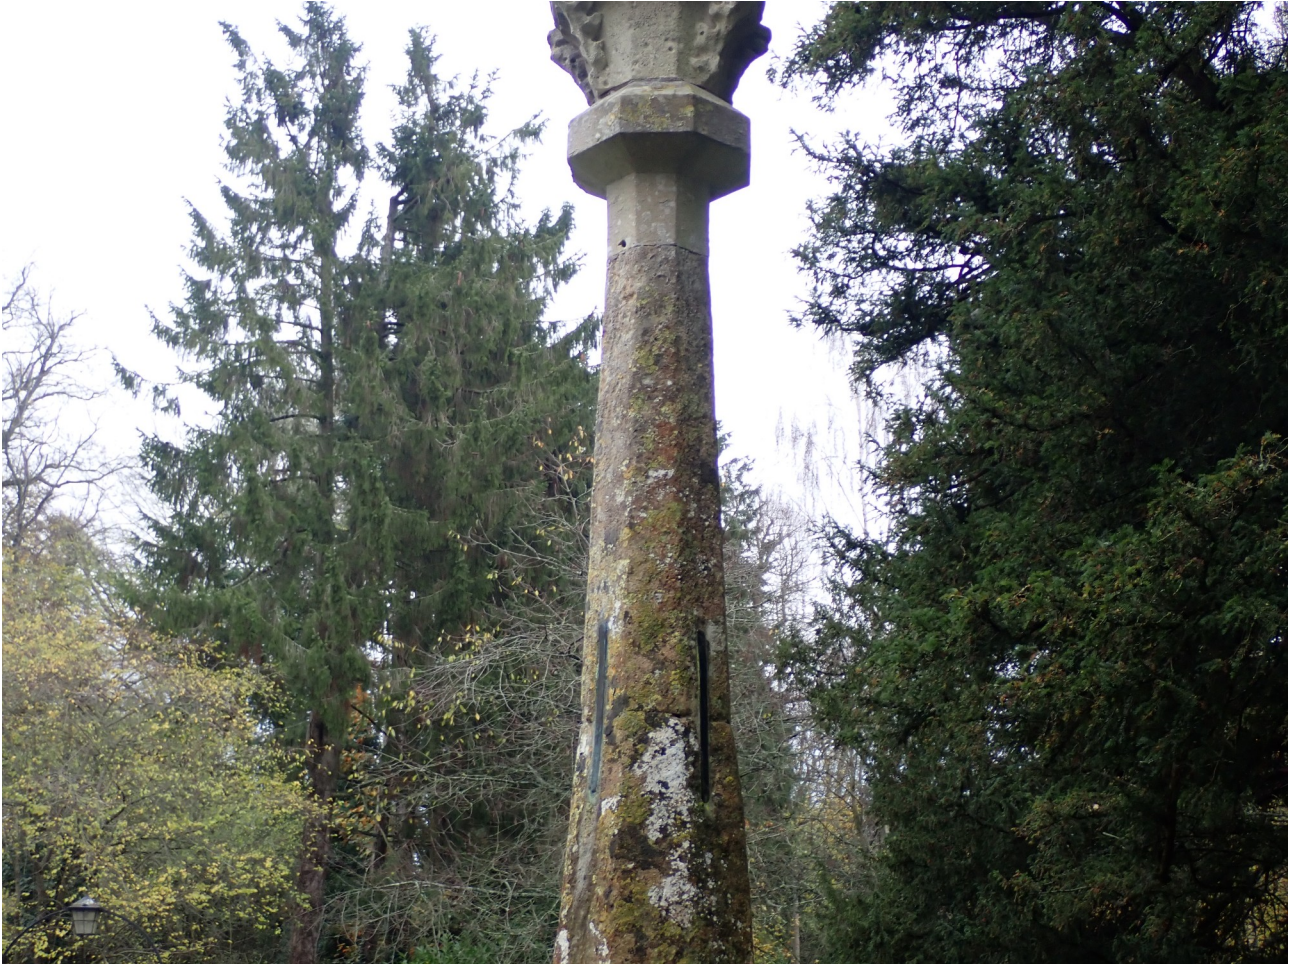
The west side. The shaft cap and bronze cramps.
